INDOOR AIR QUALITY ASSESSMENT

**Lincoln Park Community School
290 Washington Street
Somerville, MA 02143**

Prepared by:
Massachusetts Department of Public Health
Center for Environmental Health
Emergency Response/Indoor Air Quality Program
June 2005

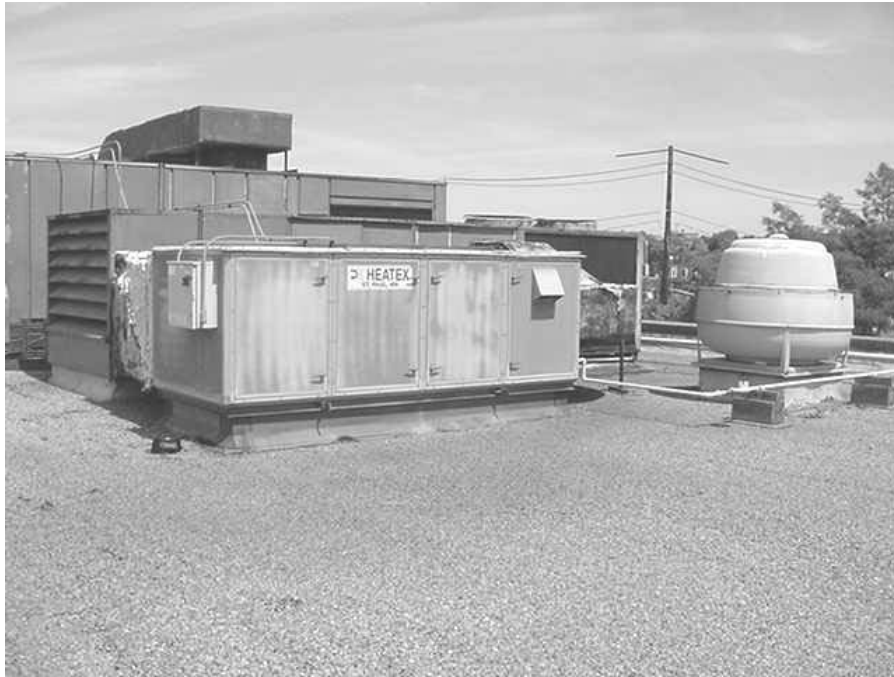
Picture 1

Mechanical ventilation is provided by rooftop air handling units (AHUs) (Picture 1). Fresh air is distributed to classrooms via ductwork connected to vents or slotted air diffusers located between ceiling tiles (Pictures 2 to 4). Return air is drawn into ceiling vents and exhausted out of the building via an exhaust fan (Picture 5). The AHU for the gymnasium was set to 'winter' (Picture 6). As a result, this AHU was either operating weakly or off at the time of assessment. Additionally, the exhaust systems for the gymnasium and some restrooms were deactivated at the time of the assessment. Moreover, some rooms did not have mechanical exhaust vents. Consideration should be given to undercutting doors for

Rooftop AHU handling unit

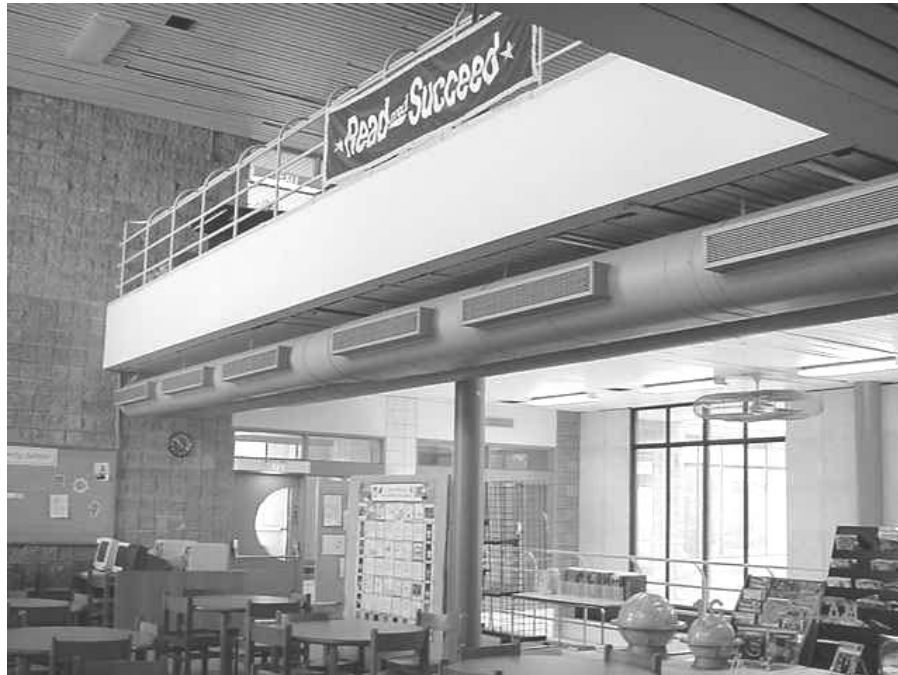
Picture 2

Ducted air supply vents

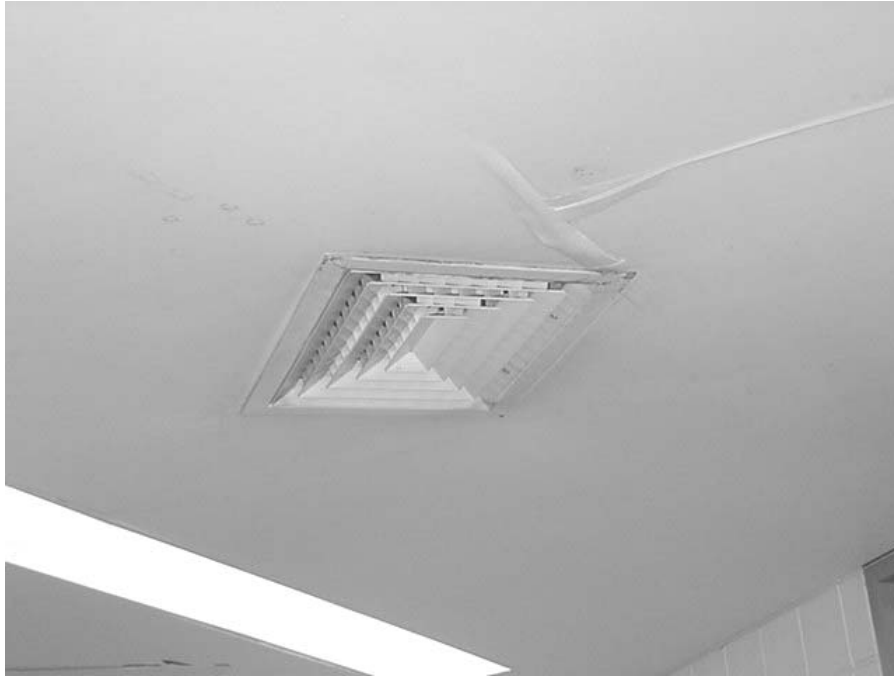
Picture 3

Ceiling supply vent

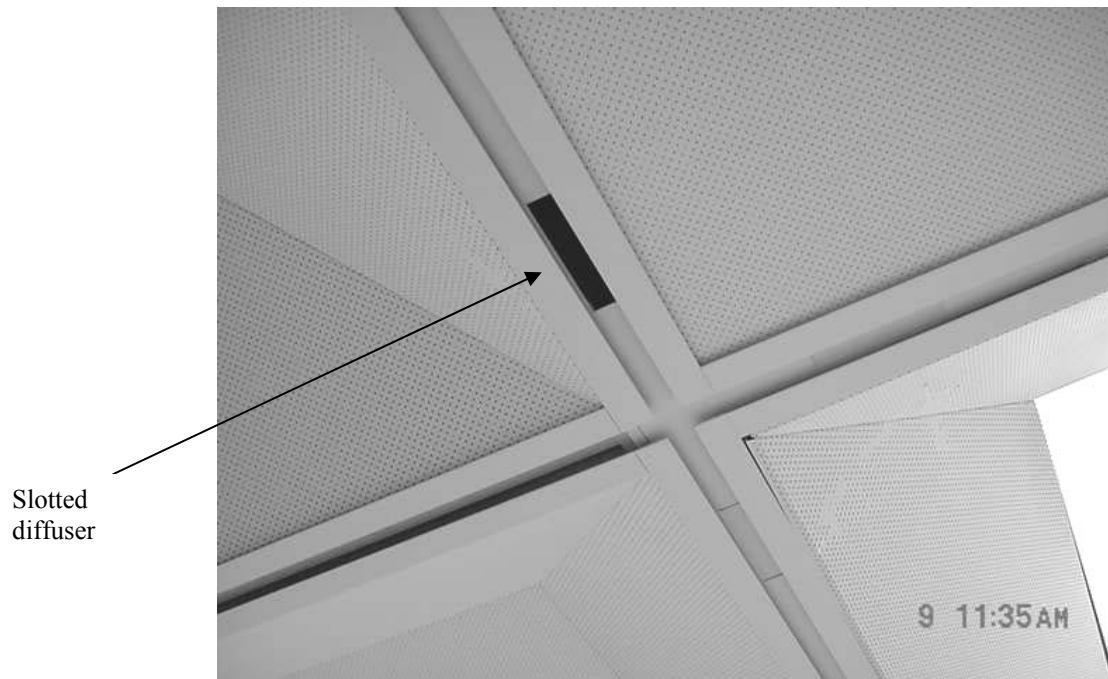
Picture 4

Slotted fresh air diffuser

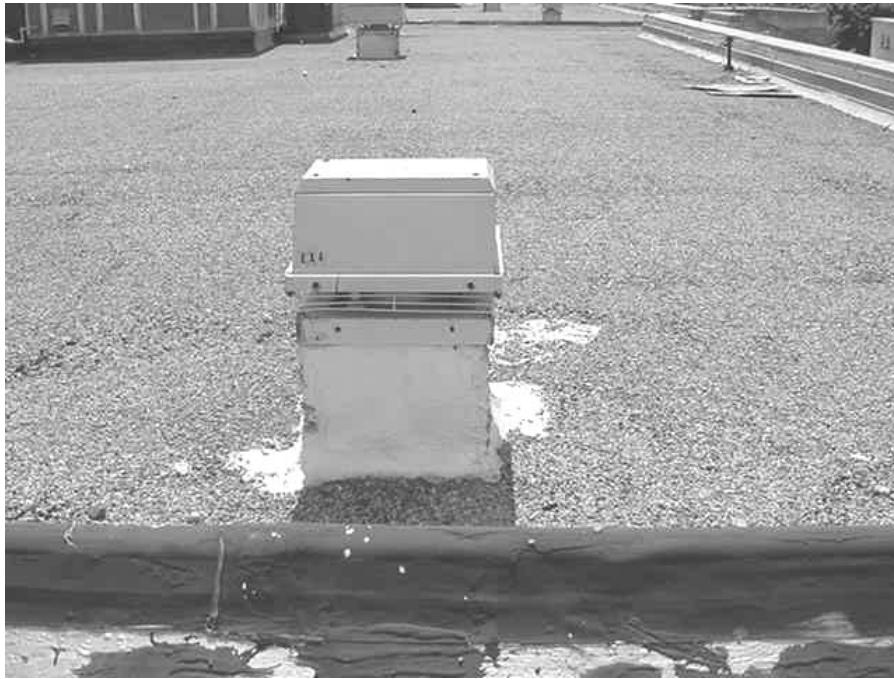
Picture 5

Rooftop exhaust fan

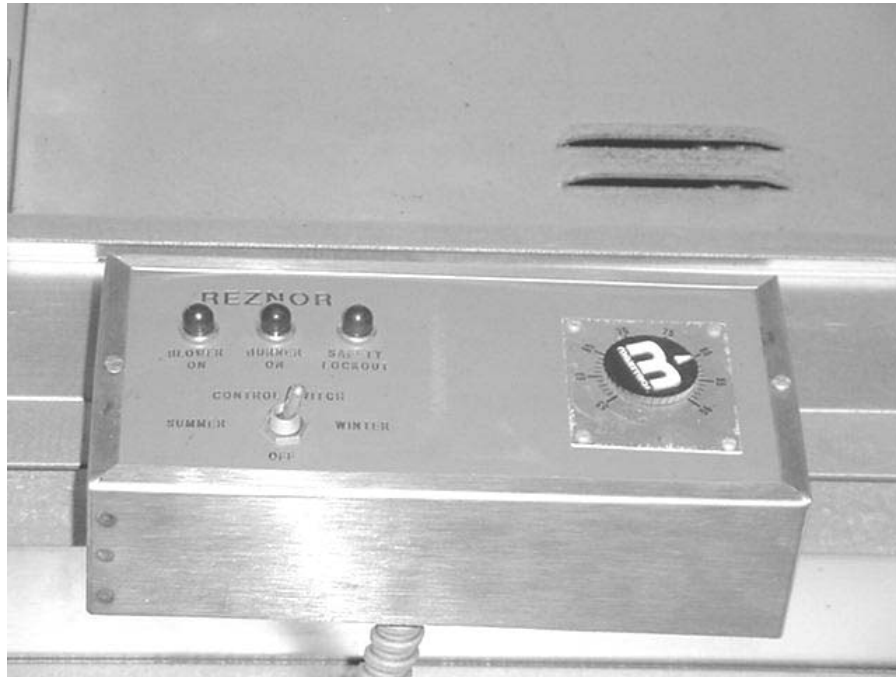
Picture 6

Gym AHU set to 'winter'

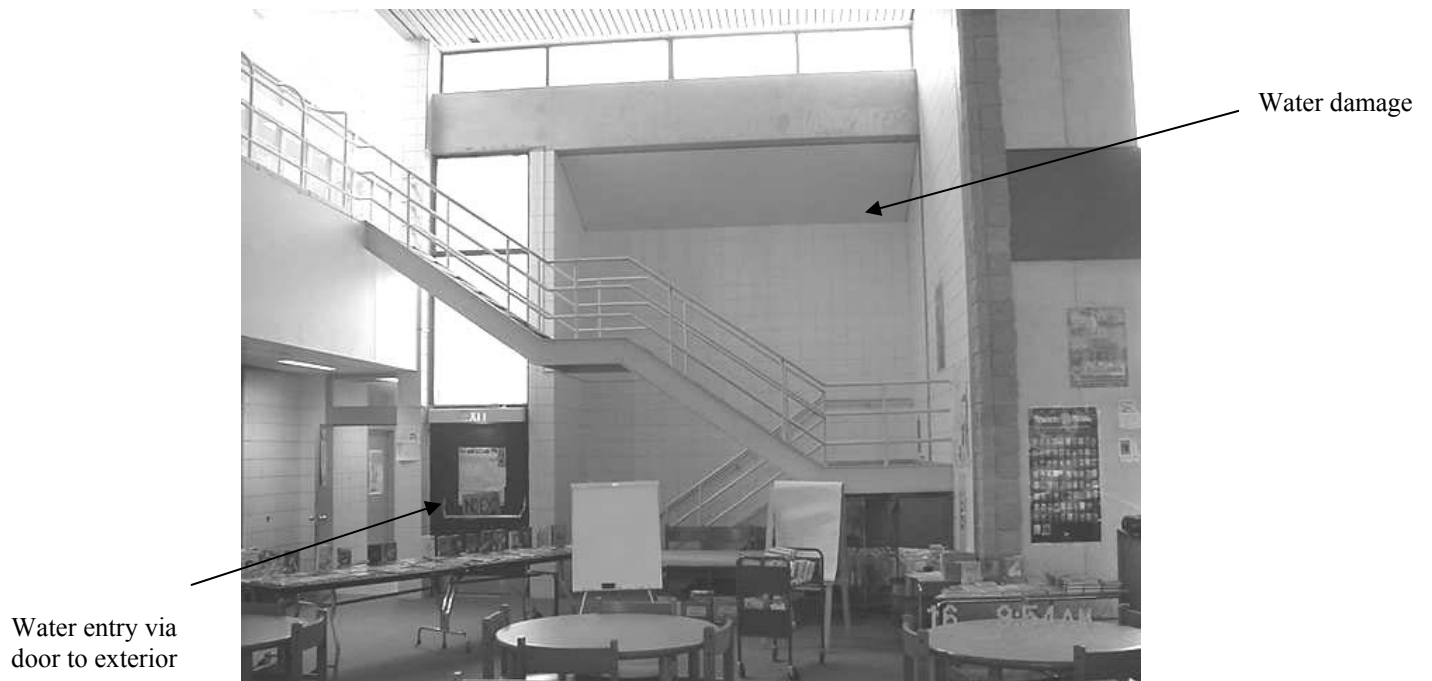
Picture 7

According to SPS staff, the LPCS has a history of water intrusion problems. When raining, water is often noted to be penetrating the library via an exterior door (Picture 7). During periods of rain, water appears to cascade down a cement wall adjacent to this access way (Picture 7), as demonstrated by the presence of efflorescence (Picture 8). Efflorescence is a characteristic sign of water damage to building materials, but it is not mold growth. As moisture penetrates and works its way through the exterior wall, water-soluble compounds dissolve, creating a solution. As the solution moves to the surface of the interior wall, water evaporates, leaving behind white, powdery mineral deposits.

Water penetrating through the library door, the roof and the wall has also damaged carpeting around the staircase. To ascertain the extent of water damage, MDPH staff took moisture readings of carpeting in the library in both affected and unaffected areas. Moisture content was measured with a Delmhorst Moisture Detector equipped with a Delmhorst Standard Probe. The Delmhorst probe is equipped with three lights that function as visual aids that indicate moisture level. Readings that activate the green light indicate a sufficiently dry or low moisture level, those that activate the yellow light indicate borderline conditions and those that activate the red light indicate elevated moisture content. Moderate moisture levels were measured in the carpeting at the corner of the library near the staircase. To prevent further damage to carpeting in the area, MDPH staff recommended removing the carpet near the door way and the staircase.

Library area with water damage

3. Remove carpeting around the exterior door and stairway of the library. Seal edges of the remaining carpet to prevent tripping.
4. Ensure all water damaged materials are removed and discarded.

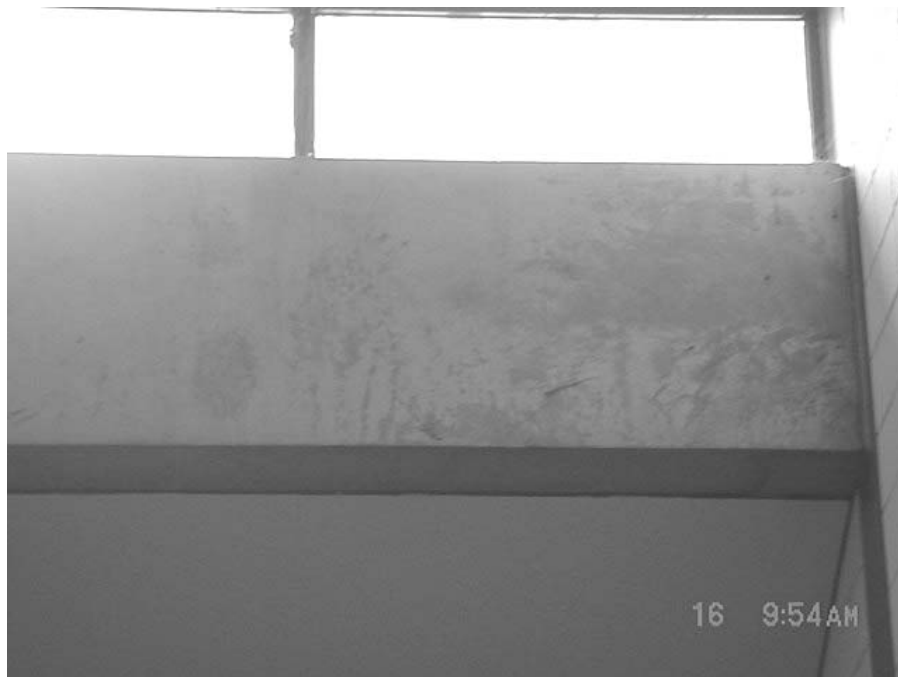
Picture 8

Efflorescence on wall in library

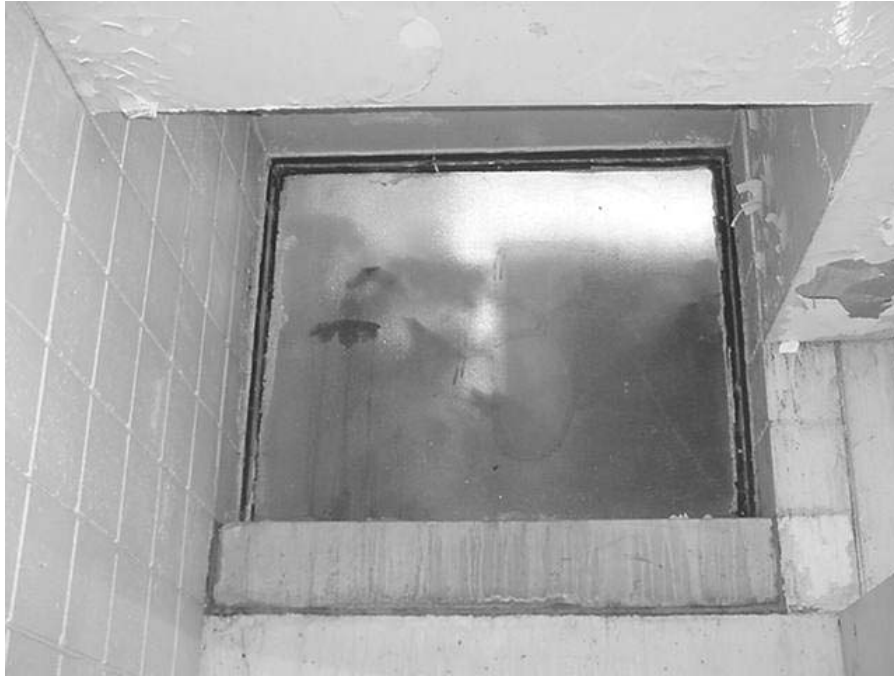
Picture 9

At the time of the assessment, MDPH staff observed water running down into the storage/girls locker room area from a damaged window (Picture 9). Water was observed to be pooling on the floor of this below grade area. It appears that the space directly outside

of the damaged window is overgrown with plants. As a result, water is being drawn in by the plant roots and held against the building. Lack of drainage and the growth of plants have likely resulted in the drainage of water *towards* the building and subsequently through the building foundation. Water penetration and pooling in this area has resulted in water damage to building materials (i.e., floor, ceiling plaster).

Window area through which water penetrates the storage/girls locker room area

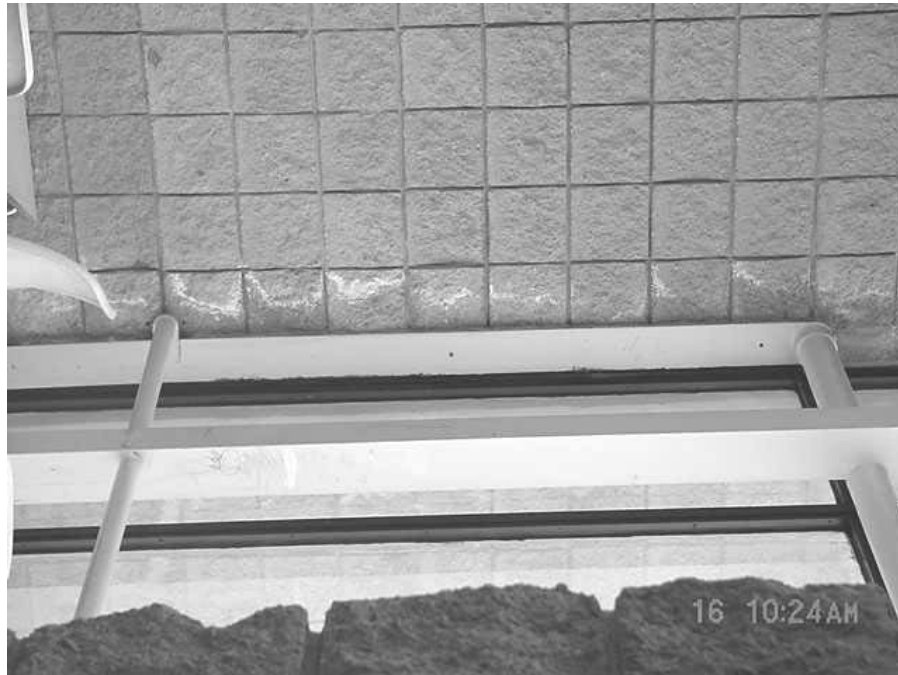
Picture 10

Efflorescence was also noted on walls and support beams in a number of staircases throughout the building, as well as around windows in a number of hallways and classrooms (Pictures 10 to 12). A trash barrel was observed beneath a reported leak in the second floor hallway near staircase B (Picture 13). As discussed, efflorescence is an indication that water is penetrating the building.

Efflorescence on ceiling above hallway window

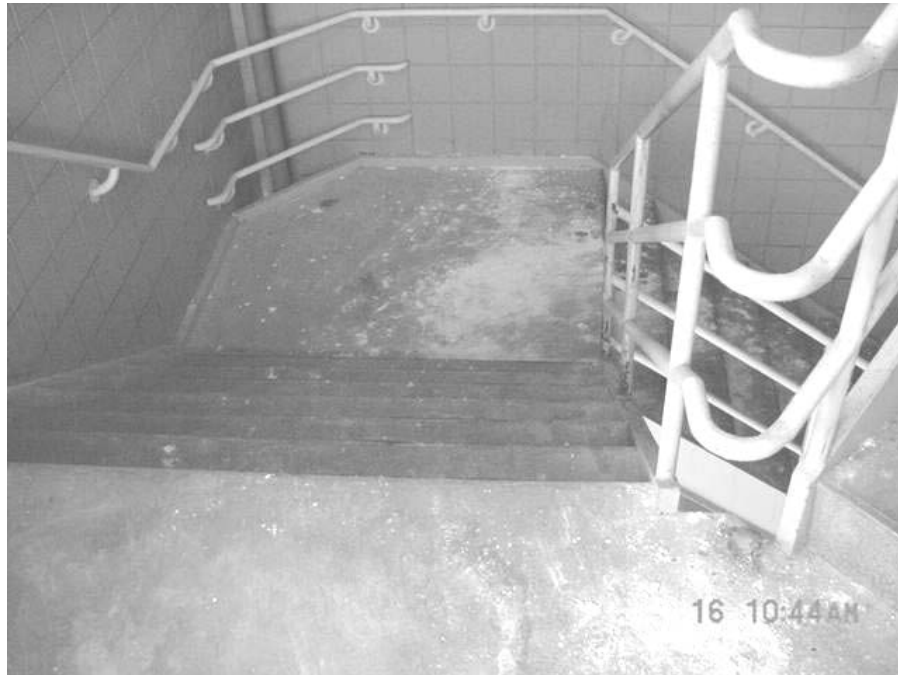
Picture 11

Efflorescence in stairway

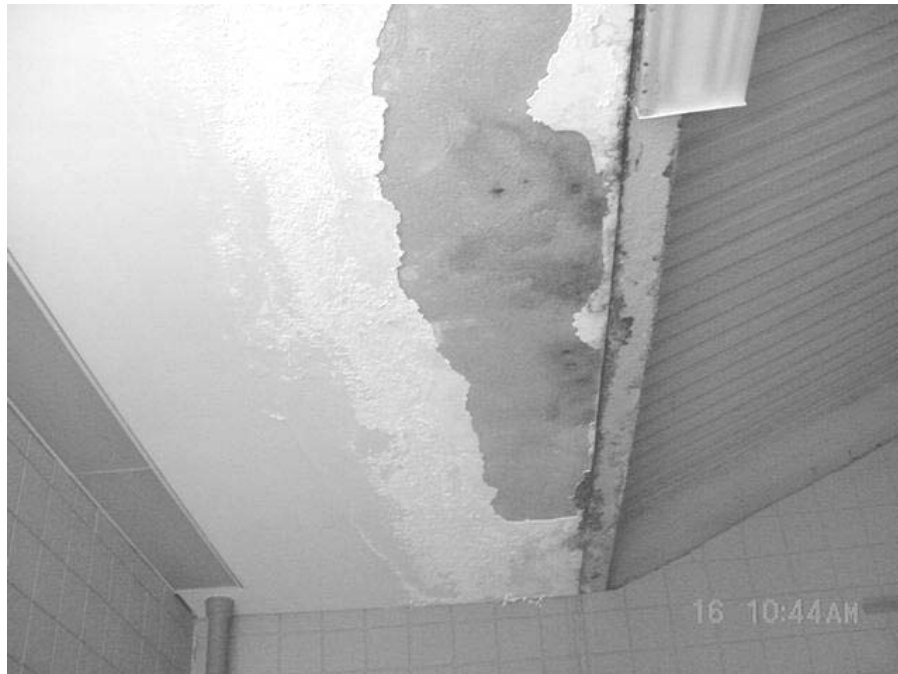
Picture 12

Efflorescence in stairway

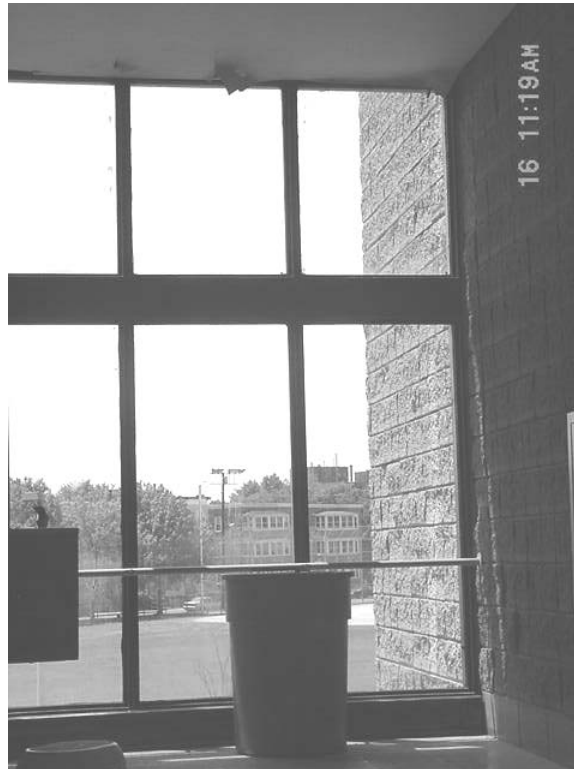
Picture 13

Trash barrel for collecting water from leak

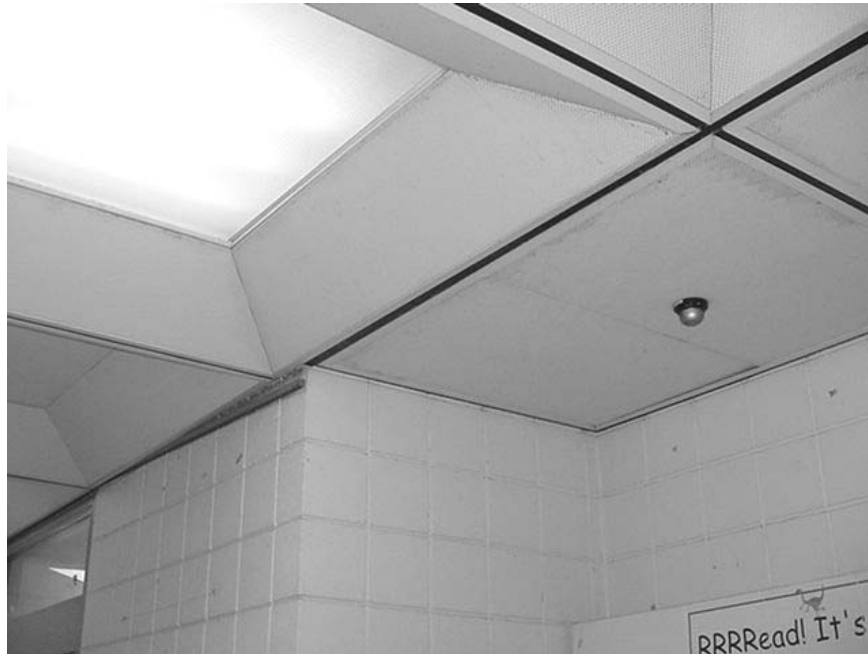
Picture 14

Some areas also had water-damaged ceiling plaster and tiles, which can indicate leaks from the roof or plumbing system (Pictures 3 and 14). Water-damaged ceiling tiles can provide a source of mold and should be replaced after a water leak is discovered and repaired. Water damaged porous materials were also noted in some areas (Picture 15). Like ceiling tiles, water damaged porous materials can provide a source for mold growth. These materials should be discarded to prevent such growth.

Water damaged ceiling tiles

5. Consult *Mold Remediation in Schools and Commercial Buildings* published by the US EPA (2001) for more information on mold. Copies of this document can be downloaded from the US EPA website at:
http://www.epa.gov/iaq/molds/mold_remediation.html.

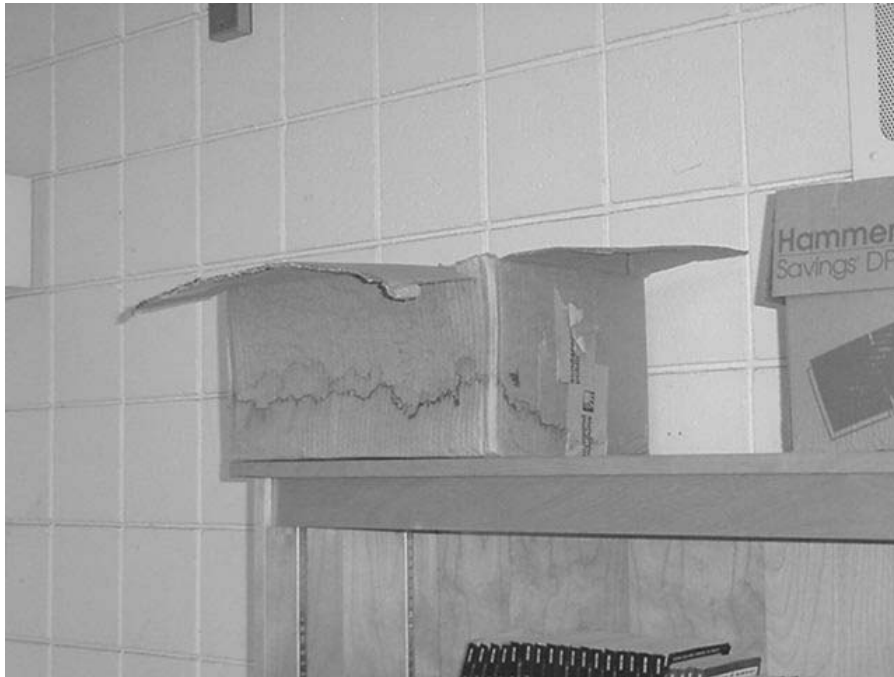
Picture 15

Water damaged corrugated cardboard box

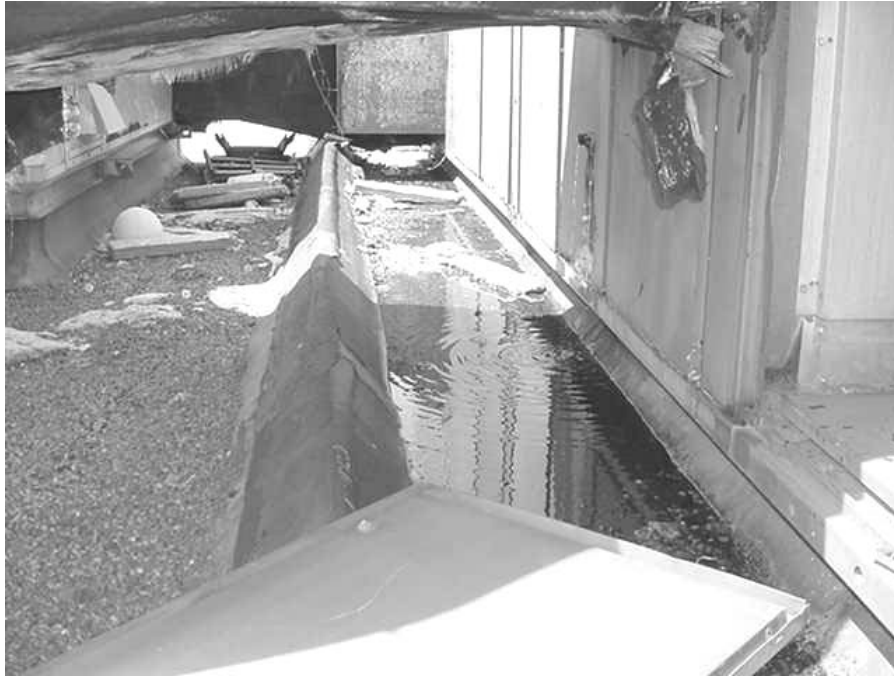
Picture 16

MDPH staff examined the roof. Pooling water was seen in some areas, indicating inadequate draining (Picture 16). Cracks and breaches were also noted in the rubber membrane. As a result of water and debris accumulation, moss growth was noted on the roof surface (Picture 17). Repairing the roof and improving surface drainage is necessary to prevent further water penetration.

Pooling water on roof

1. Seal all holes and breaches along the exterior walls and around windows and doors.
2. Contact a roofing contractor or building envelope specialist to determine the most appropriate method to repair the roof and prevent water leaks.

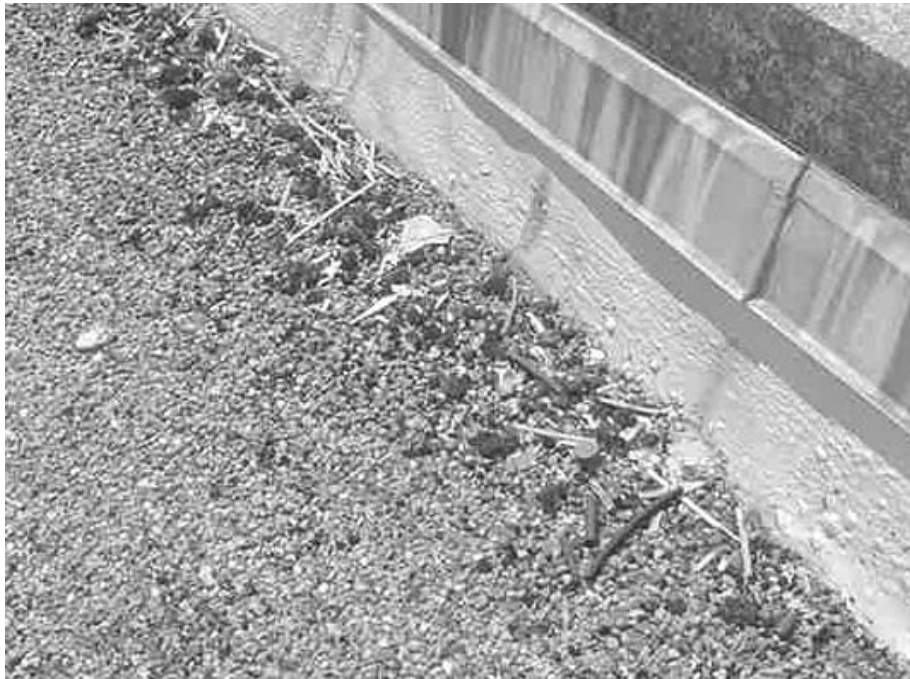
Picture 17

Moss growth on roof

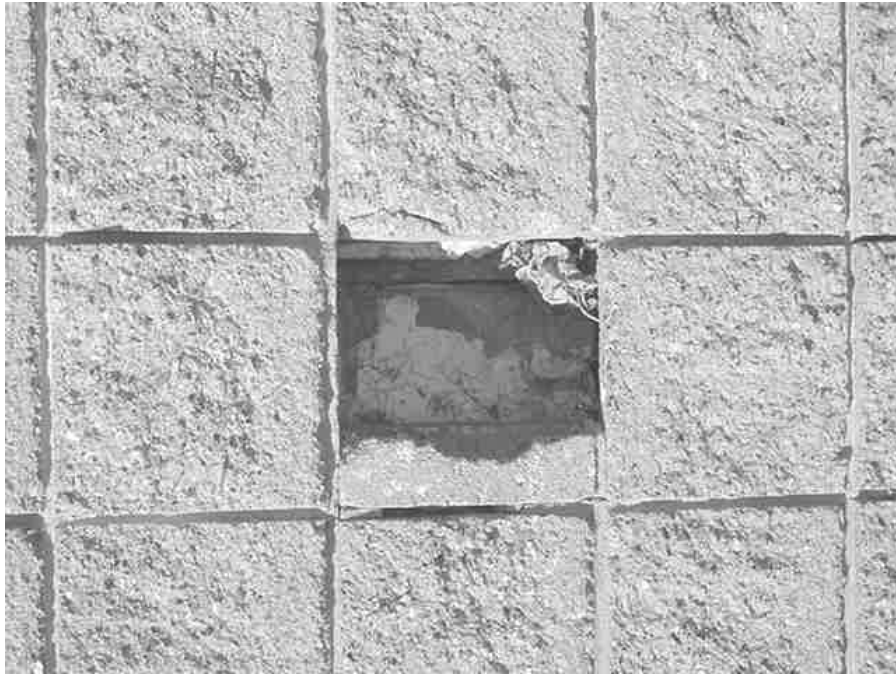
Picture 18

Damage to the exterior walls of the building was also noted (Picture 18). Missing brickwork, seams and breaches in and around brickwork were observed (Picture 19). Breaches were also noted around doors and windows. Holes, breaches, and seams are points through which water can penetrate the building, particularly under driving rain conditions.

Hole in exterior wall

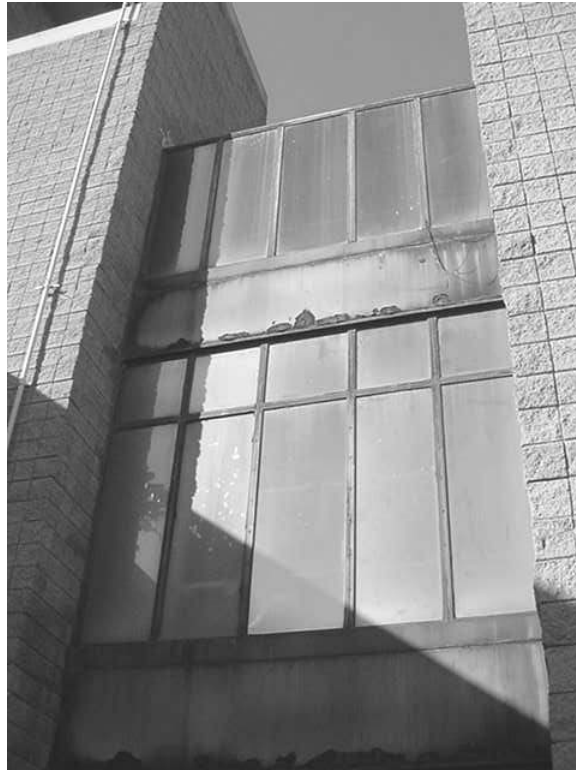
Picture 19

Damage to window system and building

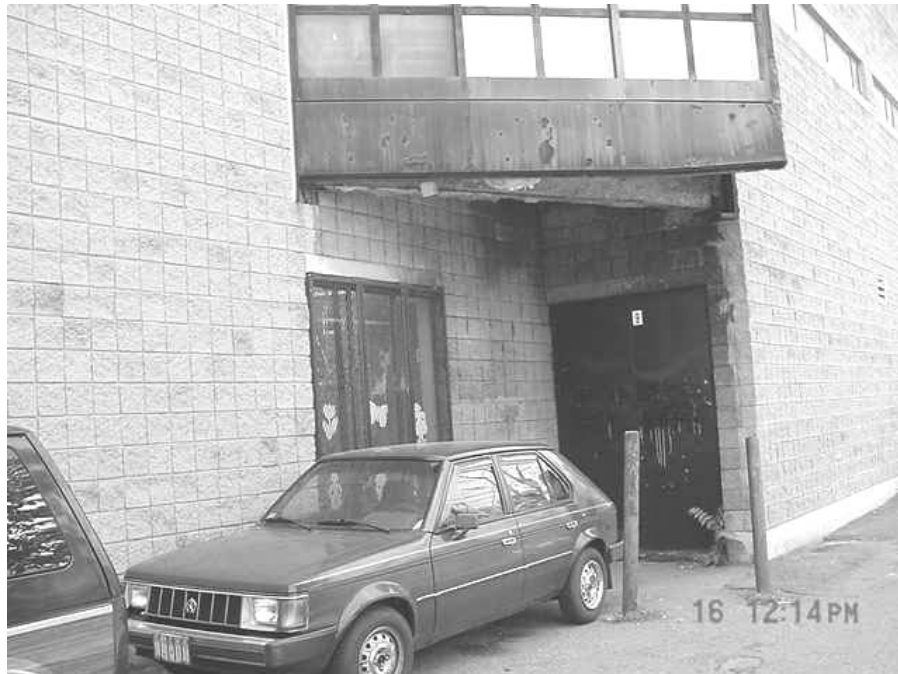
Picture 20

Significant damage was noted to an overhang above a doorway to the shipping/receiving area (Picture 20). According to occupants, the overhang was damaged when a truck backed into the building. The truck caused damage to both the roof structure and the exterior wall (Picture 21). Because of the location of the damage, water penetration is a significant problem resulting in damage to adjacent classrooms.

Overhang above shipment receiving bay

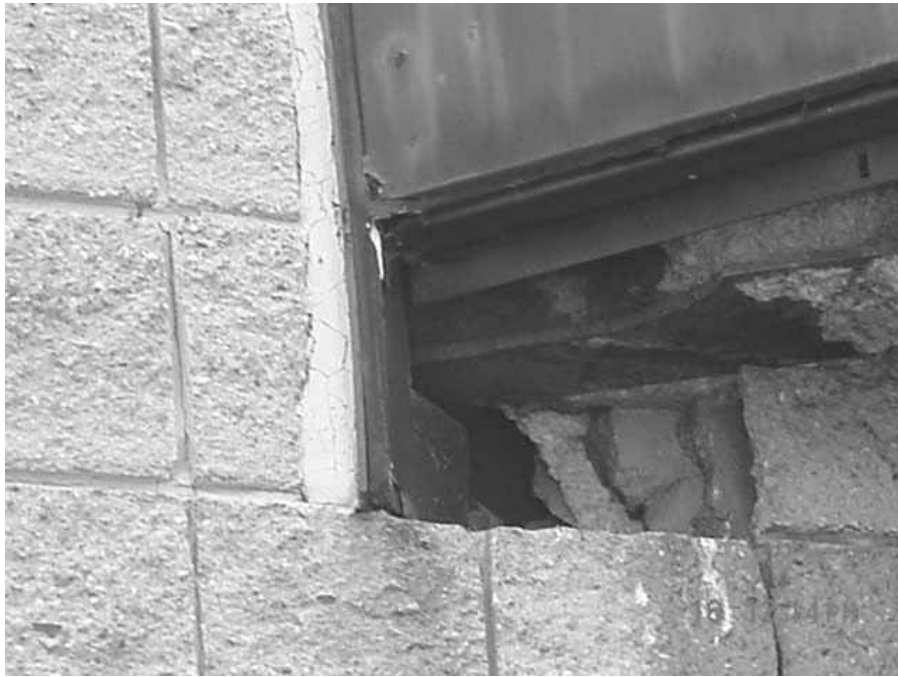
Picture 21

Damage to exterior wall and roof structure

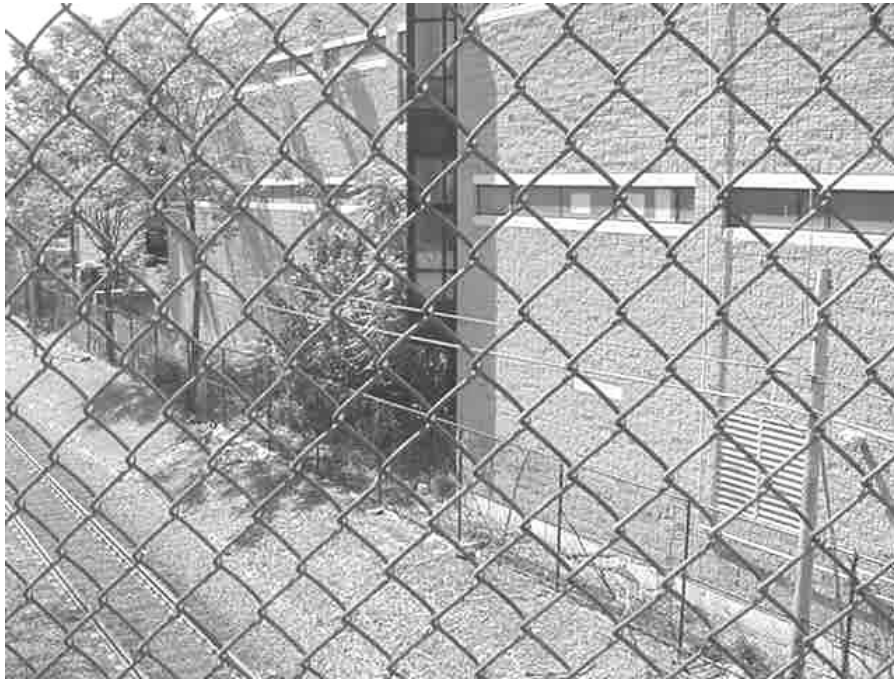
Picture 22

Plants were observed growing against the foundation walls. Extensive plant growth was noted on the building exterior facing the train tracks (Picture 22). The growth of roots against exterior walls can bring moisture in contact with the foundation. Plant roots can eventually penetrate, leading to cracks and/or fissures in the sublevel foundation. Over time, this process can undermine the integrity of the building envelope, providing a means of water entry into the building via capillary action through foundation concrete and masonry (Lstiburek & Brennan, 2001).

Plant growth against building on exterior side facing train tracks

6. Remove plant growths against the exterior wall/foundation of the building.
7. Operate both supply and exhaust ventilation continuously, independent of classroom thermostat control, during periods of school occupancy to maximize air exchange.

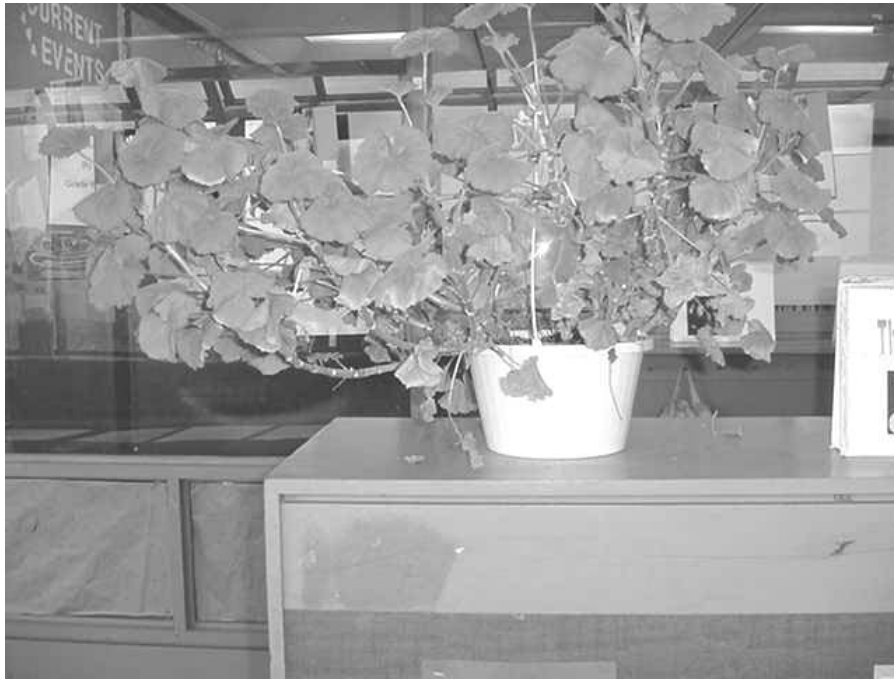
Picture 23

Plants were also observed in several classrooms (Picture 23). Plants, soil and drip pans can serve as sources of mold growth, thus should be properly maintained. Over-watering of plants should be avoided and drip pans should be inspected periodically for mold growth. Plants should also be located away from ventilation sources to prevent aerosolization of dirt, pollen or mold.

Plants in classroom

11. Seal breaches, seams, and spaces between sink countertop and backsplash to prevent water damage.
12. Ensure plants have drip pans. Avoid over watering and examine drip pans periodically for mold growth. Disinfect with an appropriate antimicrobial where necessary.

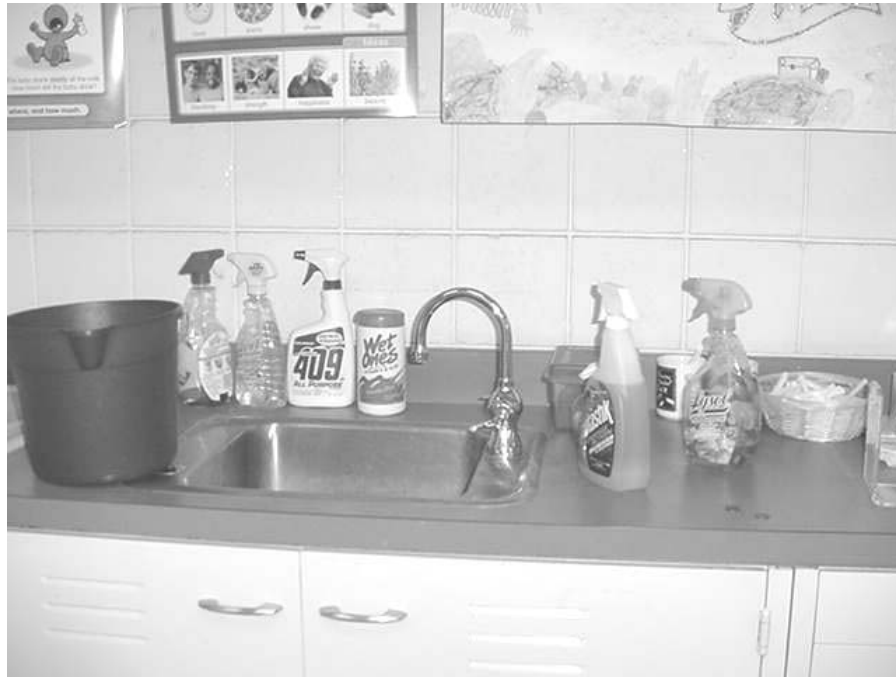
Picture 24

Cleaning products were found on countertops and in unlocked cabinets beneath sinks in some classrooms (Picture 24). Like dry erase materials, cleaning products contain VOCs and other chemicals that can be irritating to the eyes, nose and throat of sensitive individuals. Also of concern are unlabelled bottles and containers. Products should be kept in their original containers and be clearly labeled for identification purposes, especially in the event of an emergency.

Cleaning products on sink counter

16. Store cleaning products properly and out of reach of students. Ensure spray bottles are properly labeled.
17. Relocate or consider reducing the amount of materials stored in classrooms to allow for more thorough cleaning. Clean items regularly with a wet cloth or sponge to prevent excessive dust build-up.

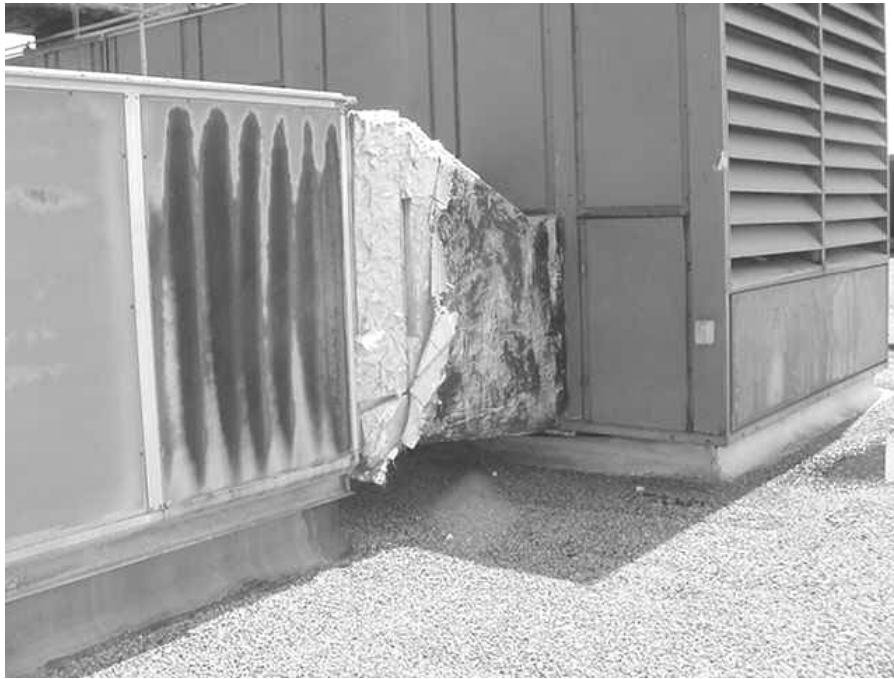
Picture 25

Several other conditions that can affect indoor air quality were noted during the assessment. MDPH staff noted severe damage to insulation around ducts for rooftop AHUs (Picture 25). Damaged insulation should be removed and replaced to ensure

appropriate and proper functioning of the AHUs. Without proper insulation, the AHUs may not be able to provide the appropriate tempered air.

Damaged AHU insulation

13. Remove and replace damaged AHU insulation.
14. Remove aged and damaged materials from the roof.
15. Clean dry erase board trays and pencil sharpeners regularly to avoid build-up of particulates.

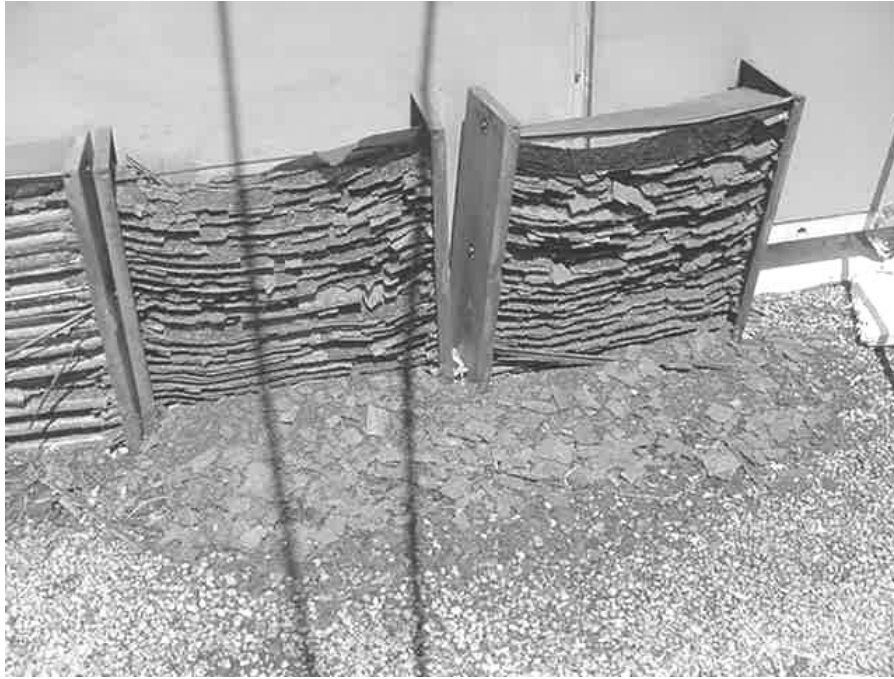
Picture 26

Deteriorating materials were also noted on the roof, in close proximity to the fresh air intake of the AHU (Picture 26). These materials should be removed to prevent further damage to the roof and to eliminate any possible source of odor that could be entrained into the roof top AHU. Entrainment of such materials may result in distribution of materials to the interior school environment.

Damaged and aged materials on roof

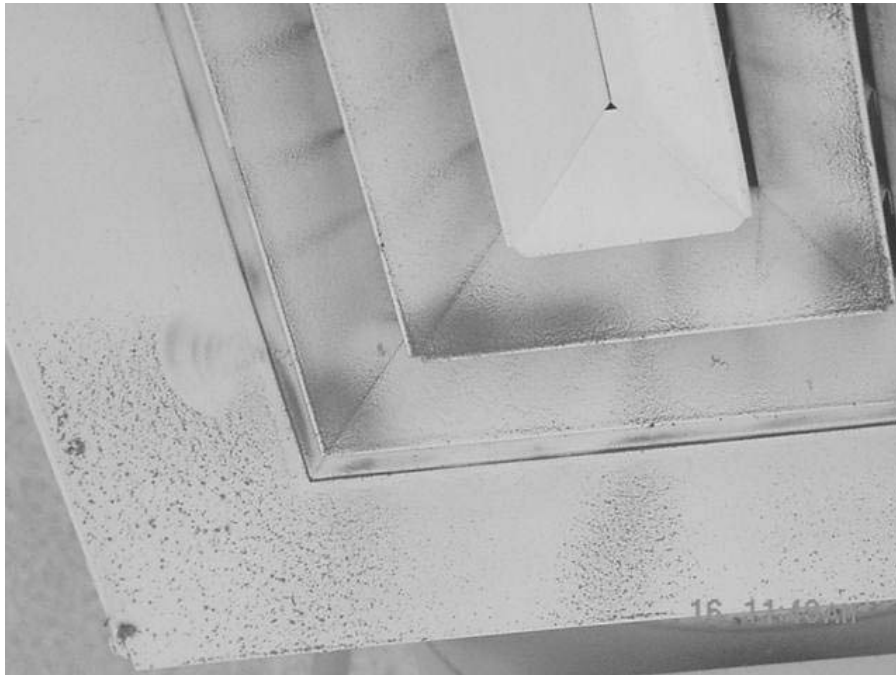
Picture 27

Dust was noted to have accumulated on many surfaces. A number of supply and exhaust vents in classrooms were also noted with accumulated dust (Pictures 27 and 28). Air from supply vents can aerosolize dust accumulated on the vents. If exhaust vents are not functioning, back-drafting can re-aerosolize accumulated dust particles. Dust can be irritating to the eyes, nose and respiratory tract. Missing and ajar ceiling tiles were observed in several areas. Missing ceiling tiles can serve as pathways for dust, dirt, odors and other pollutants to move into occupied areas. Tiles should be replaced to prevent movement of particles.

Supply vent with accumulated dust

18. Clean supply, exhaust and return vents periodically to prevent excessive dust build-up.
19. Consider discontinuing the use of tennis balls on chair legs.

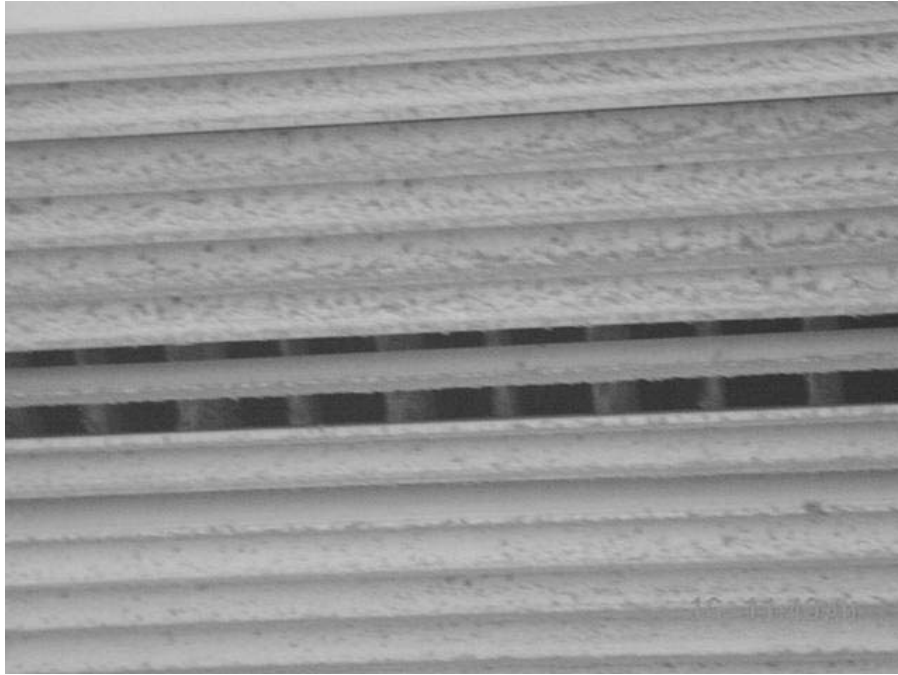
Picture 28

Exhaust vent with accumulated dust

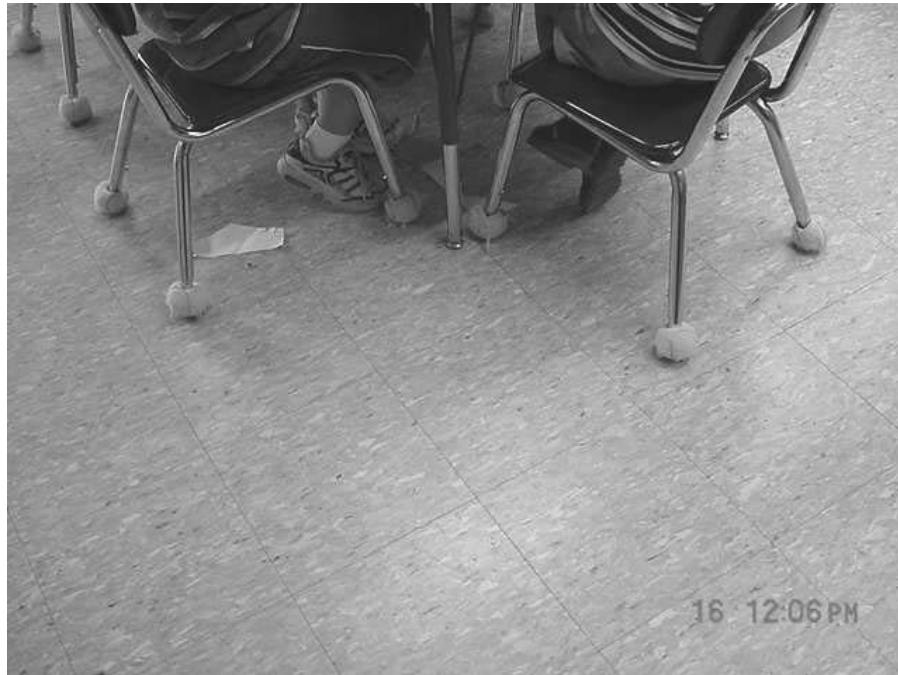
Picture 29

In an effort to reduce noise from sliding chairs, tennis balls had been spliced open and placed on chair legs (Picture 29). Tennis balls are made of a number of materials that are a source of respiratory irritants. Constant wearing of tennis balls can produce fibers and off gas VOCs. Tennis balls are made with a natural rubber latex bladder, which becomes abraded when used as a chair leg pad. Use of tennis balls in this manner may introduce latex dust into the school environment. Some individuals are highly allergic to latex (e.g., spina bifida patients) (SBAA, 2001). It is recommended that the use of materials containing latex be limited in buildings to reduce the likelihood of symptoms in sensitive individuals (NIOSH, 1997). A question and answer sheet concerning latex allergy is attached as [Appendix B](#) (NIOSH, 1998).

Tennis balls in chair legs
